TECHNICAL REPORT GL-81-8

EVALUATION OF QUALITY AND PERFORMANCE OF STONE AS RIPRAP OR ARMOR

Richard J. Lutton, Billy J. Houston, James B. Warriner

September 1981

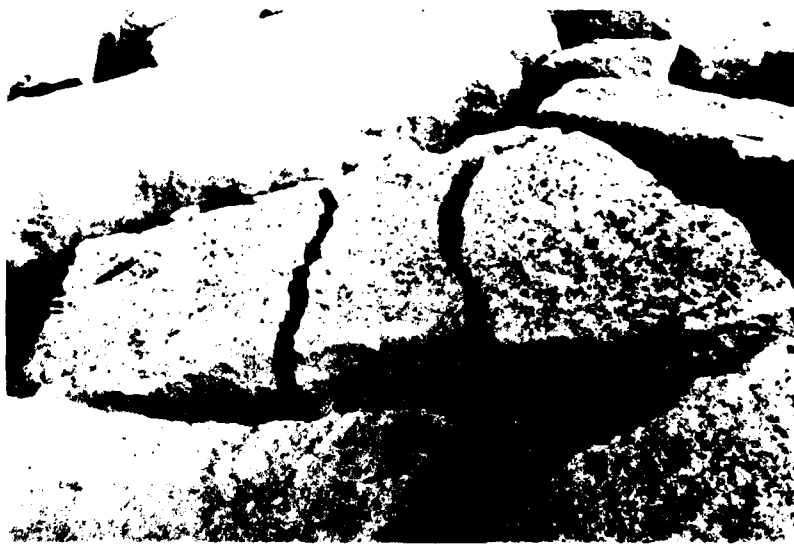
19. Figure 1 illustrates the arrangement of cracks in a representative block. It was common to find that bedding, though visually faint, was sufficient to establish influential anisotropy. By far most cracks either followed parallel or crossed perpendicular to bedding. Cracking in no way could be dismissed as spalling of corners or pervasive disintegration. Instead, the cracks were clean, simple, and few; in some cases, the blocks were divided in half.

Figure 1. Cracking of armor stone on dike in Lake Michigan (note pencil at left)

20. Where cracked blocks were numerous on the dike, they potentially compromised the armor design by greatly reducing the median (percent weight) block size. On the other hand, most of the cracks observed during this study (i.e., within a few years after placement) had not resulted in complete separations. The parts of the cracked stones usually remained together, wedged in place, or still partially joined.

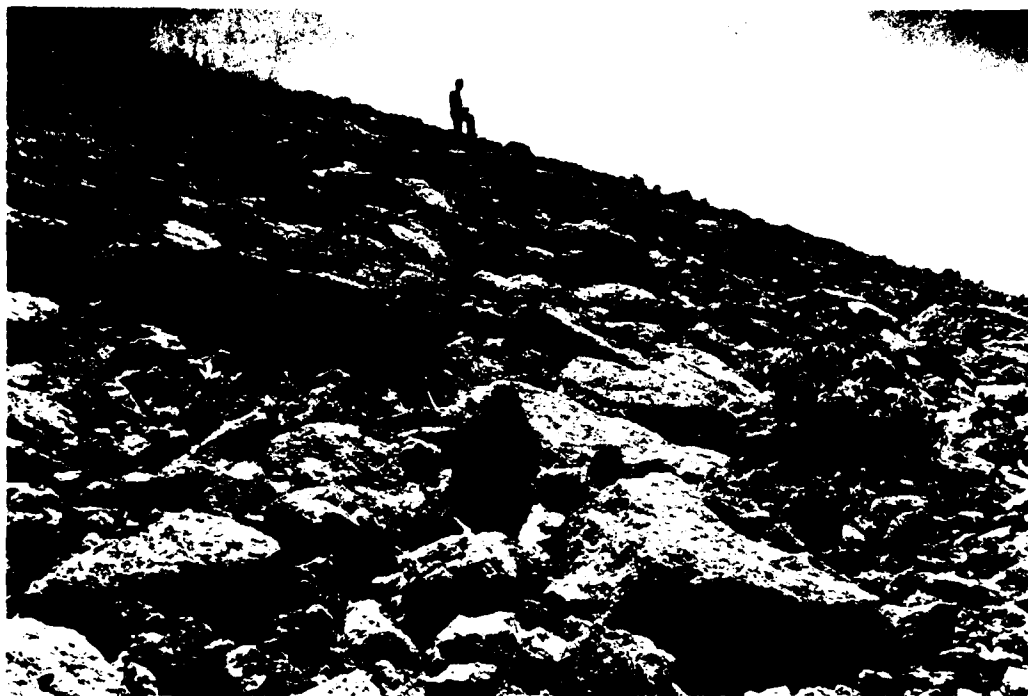
Figure 5. Disaggregating of conglomerate at Eagle Mountain Lake

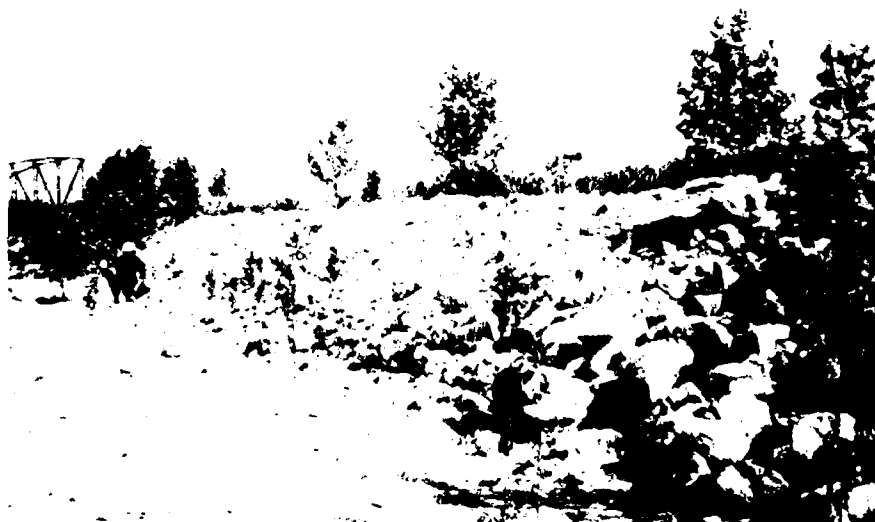
- a. Approximately half of the original pieces have been reduced in size by weathering while there is less effect on the larger pieces; they do have solution channels developing along incipient cracks

Figure 6. Riprap at Hazard Perry site

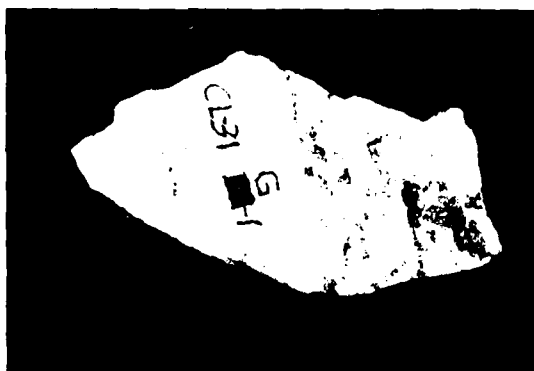
Dolomite CL-31G-1

Figure A1. Results of freezing-and-thawing test CRD-C 144

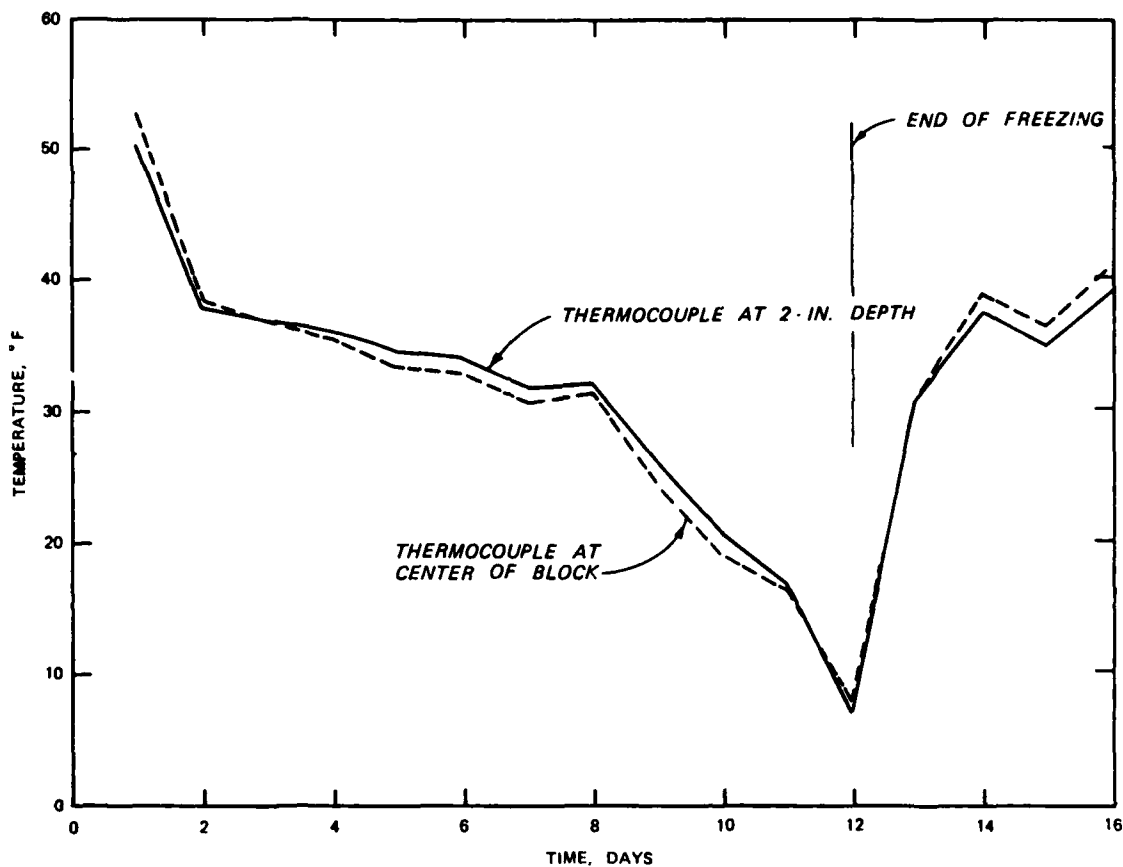
Figure A5. Cycle 1 of freezing and thawing of dolomite stone
